## Restoring a Russian Zvezda 'Red Star' Model 54

Gary Albach, July 2020, Victoria, Canada

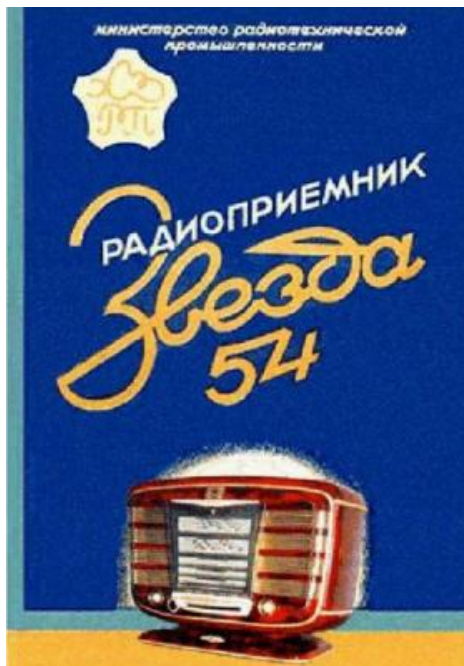
The Zvezda was a copy of a French design, the SNR Excelsior 52. The Russians even copied the naming tradition, the French 52 was from 1952, the Russian 54 was introduced in 1954.

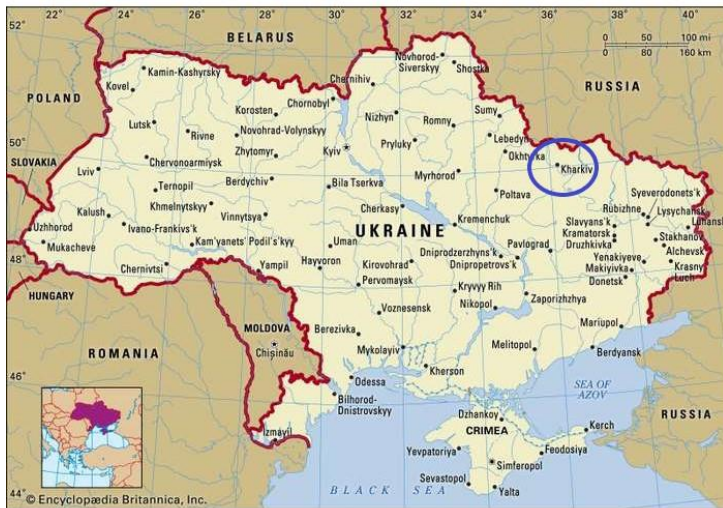
There were two factories in the USSR where these sets were manufactured. The first to start production in 1954 was in the Kharkov (Institute of Instrument-Making and Technologies) Komunar Works (Productive Association), located in Kharkiv, Ukraine, then part of the USSR (see map). The initial design had a vertical chassis, like the one that I have; in 1955 the chassis was redesigned to be horizontal and production started at a second plant in Moscow.

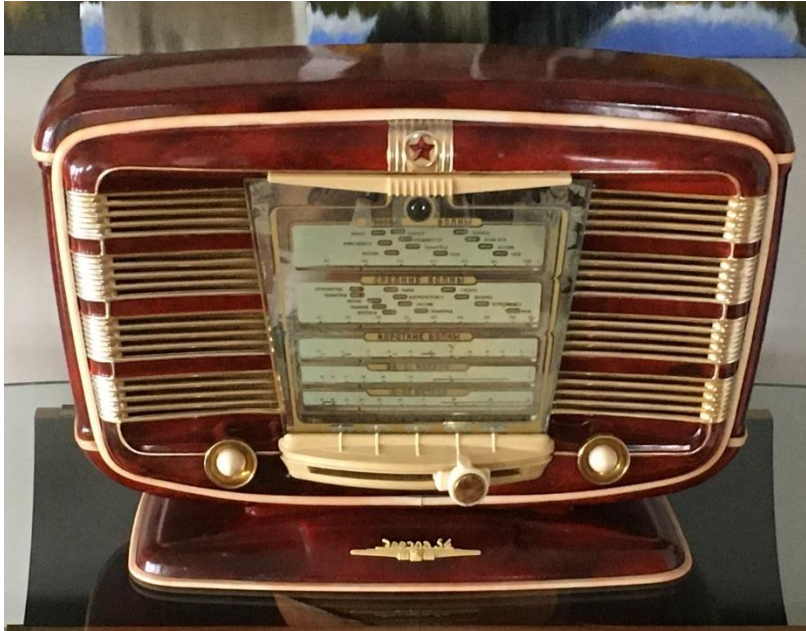
*There were many design problems. The metal cabinet caused resonance in the audible range (between 1000 and 3000 Hz), that is why the inside of the cabinet is covered with felt. This again led to higher internal temperatures. New loudspeakers had to be designed for the receiver as the quality of Russian loudspeakers was not very high. The production of miniature tubes had just started. These tubes were scarce and not all types were available. That is why an older tube like the 6A7 was used. Also its too "Western" and at the same time somewhat "vulgar" design, led to some resistance in the political leadership.'*

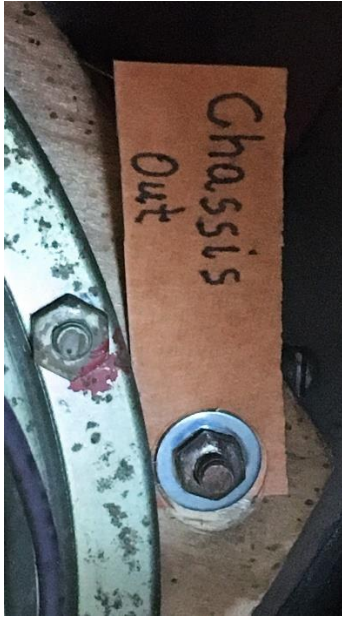
The most difficult job at first was getting the chassis out of the cabinet, and then back in. The chassis is bolted to a plywood speaker baffle board from the front, and the baffle board in turn is secured to the inside front of the cabinet with nuts on four threaded studs protruding through the plywood. Removing these nuts from the back frees the chassis assembly to slide backwards. It was not obvious that these four small nuts secure the entire chassis in the cabinet, so thankfully during a previous repair they had been labeled in four separate languages – English, Polish, French and Russian!

The problem getting the chassis out is that the baffle board is wider than the opening in the back of the cabinet. No amount of jockeying (and cursing!) could get the very heavy chassis through the opening, so I finally resorted to partially disassembling the sheet metal panels on one side of the cabinet and bending them slightly outward. Getting the chassis back into the cabinet was the reverse operation, leveraging it back in with a screwdriver, with the added frustration of having to reinstall the stiff cream coloured rubber trim strips between the sheet metal sections. The second time I removed the chassis, it came right out with a minimal amount of jockeying. In hindsight, both times the band selector lever was one notch to the right of centre, on the broadcast band looking from the front, and during my second removal I angled the right side of the chassis forward, looking from the back.

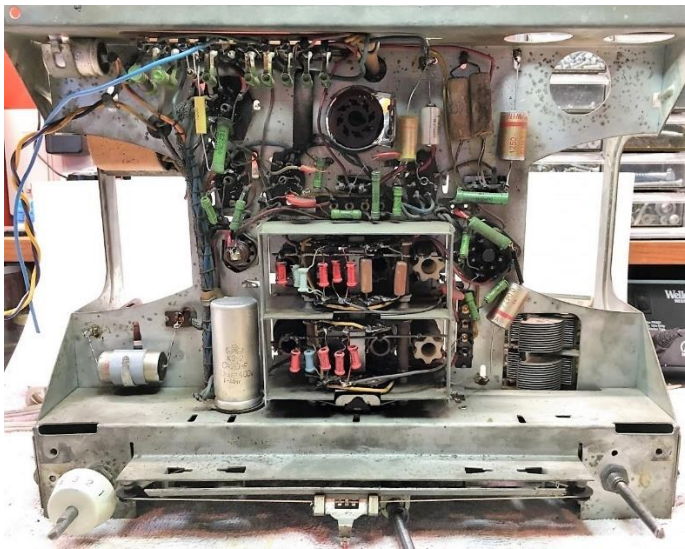
The original electrolytic caps were still installed, but after 65 years I thought it time to replace them. Because of obvious modifications already done on the power supply (addition of a solid-state bridge rectifier and associated bypass capacitors) I didn't feel badly about adding new electrolytics under the chassis rather than restuffing the old cans.

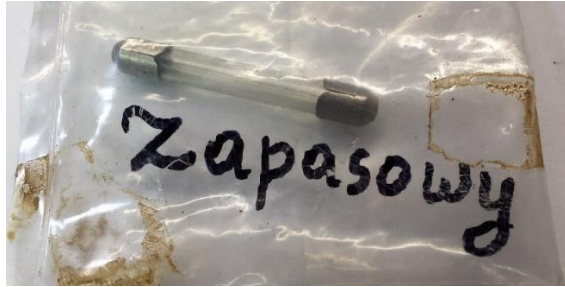
There was a spare fuse taped to the inside and labelled 'Zapasowy', which Google Translate tells me is Polish for 'spare'. The printing was the same as on the four labels denoting the nuts to remove the chassis, so might the radio have been serviced in Poland?

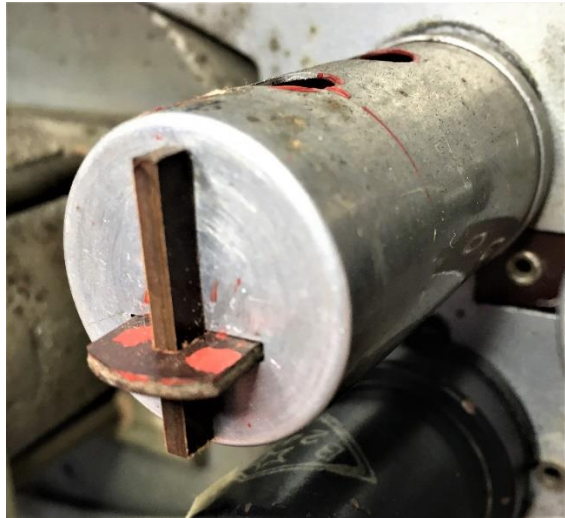
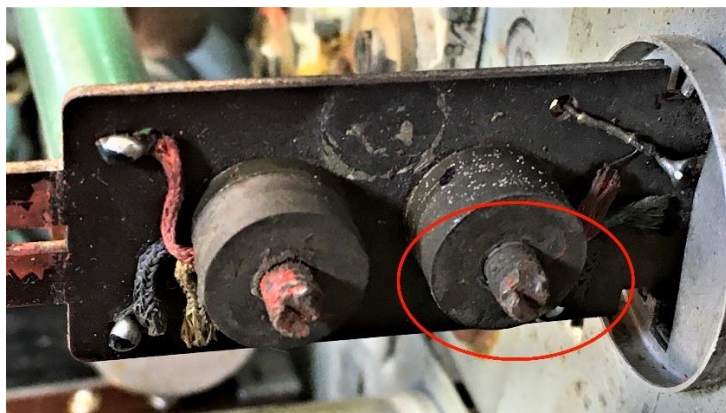
The IF transformers also proved to be a new experience for me as well. The adjacent pictures show that the coils are mounted side-by-side inside metal cans, adjustable horizontally through holes in the sides of the cans. An interesting aside was the way the can was secured to the chassis – as seen in the picture, there was a simple tapered Bakelite chock inserted into a protrusion from the interior coil assembly and jamming the can down against the chassis. The powered iron slugs inside were firmly corroded into the coils and the slots were broken open but were freed with a few drops of WD40 overnight.

The threaded slugs were then held in a vise with rubber jaws, tiny drops of JB KwikWeld applied to the broken tops, and new slots cut with a small hacksaw.

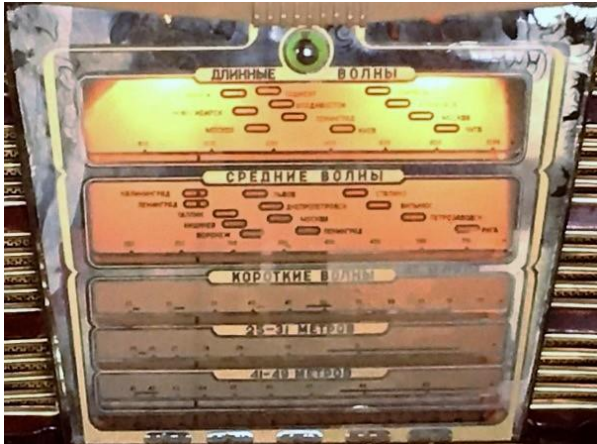
The lettering and silvering on the back of the large glass dial were intact except for around the edges where the silver had cracked and flaked over time. There is no reason to remove the dial glass to service the radio, so I photographed it for posterity and left it in place to add to the 'patina' of the cabinet.
